# Post Occupancy Evaluation

## A Classic Detective Game

**Julie Hendricks, AIA, LEED AP**

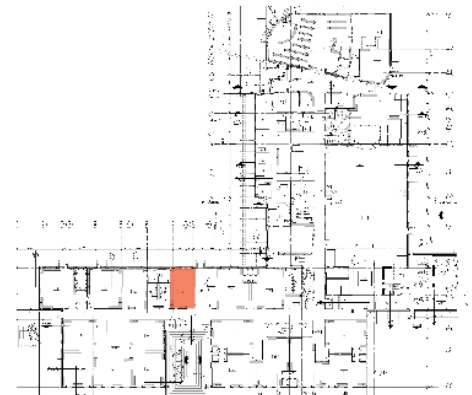
- ▶ The most significant maintenance issue is ongoing issues with the air conditioning units
- ▶ The standard occupied setpoints for the building is 72° for cooling and 80° for heating
- ▶ Building zones are isolated to minimize energy use
- ▶ The HVAC systems are right sized for the building
- ▶ Room 177 receives the most complaints in the school about it being too hot
- ▶ The low-flow plumbing fixtures are somewhat satisfactory, often having issues with miscalibrated or malfunctioning auto sensors
- ▶ The drip irrigation system used on site has issues with some of the tubing coming loose
- ▶ Satisfaction was reported towards the green housekeeping being practiced

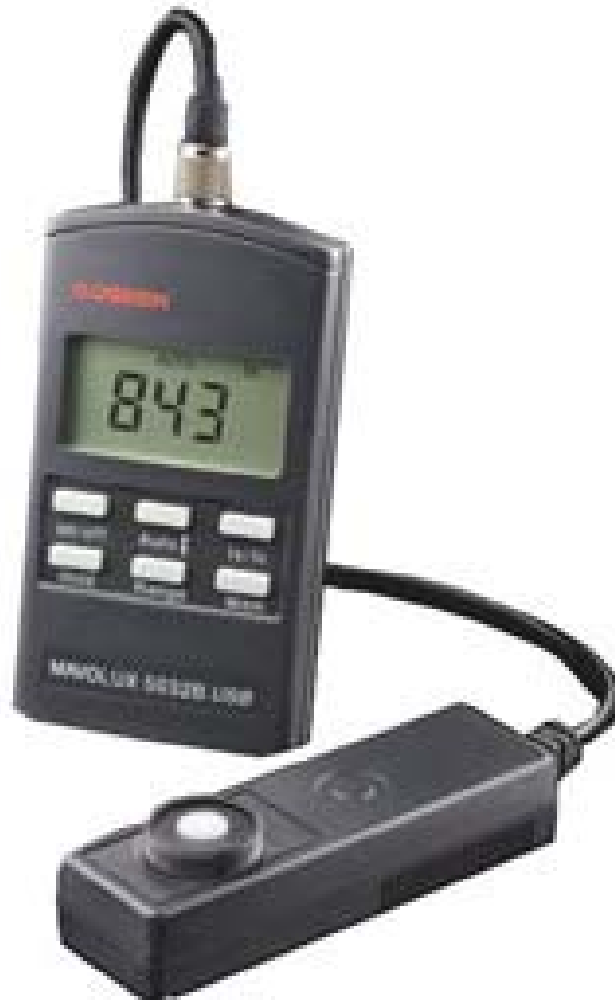
Anything above  
considered  
uncomfortably  
bright

5,000 Lux

Anything below  
considered  
uncomfortably  
dark

250 Lux

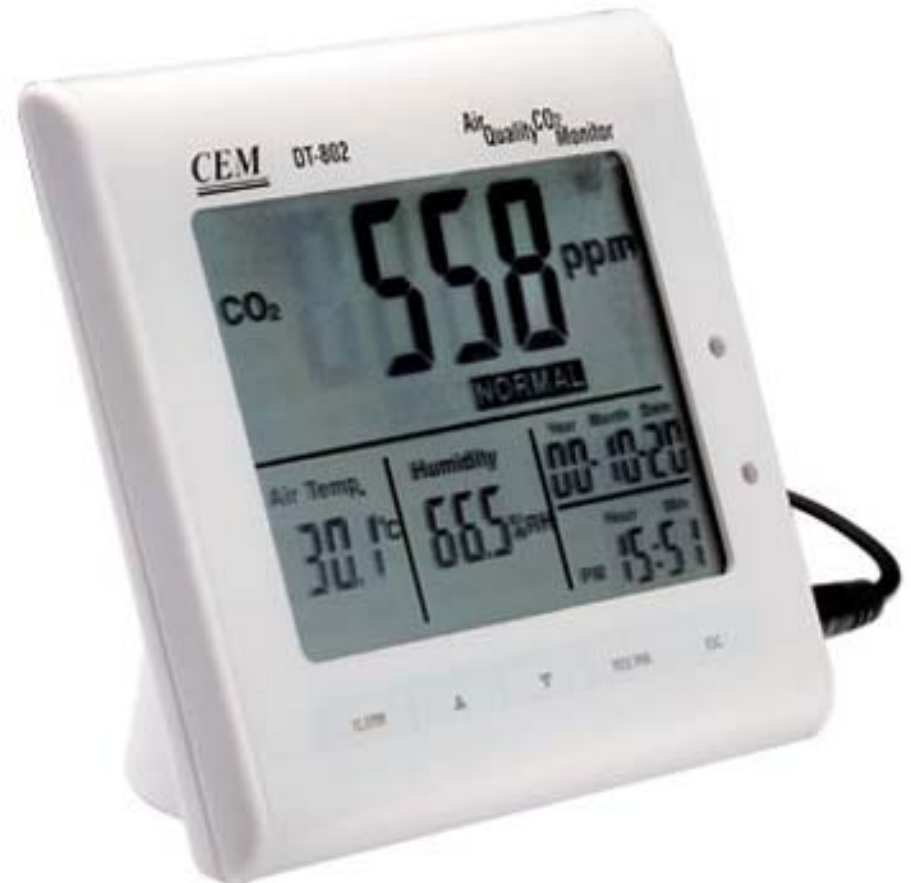
Drowsiness may occur

1056 ppm

Average Outdoor  
CO2 Level

400 ppm

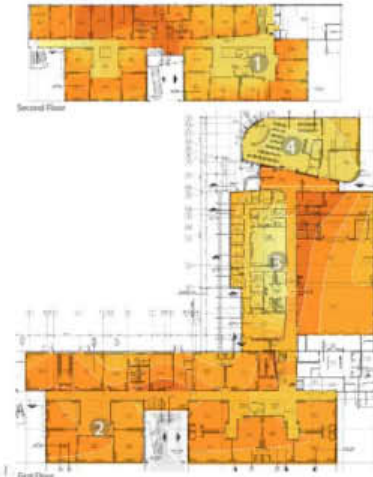
Morning Measurements-Summer Occupancy

Second Floor  
1,1410 lux 2,750 lux 3,2920 lux 4,1860 lux

First Floor  
1,1420 lux 2,670 lux 3,4000 lux 4,1590 lux

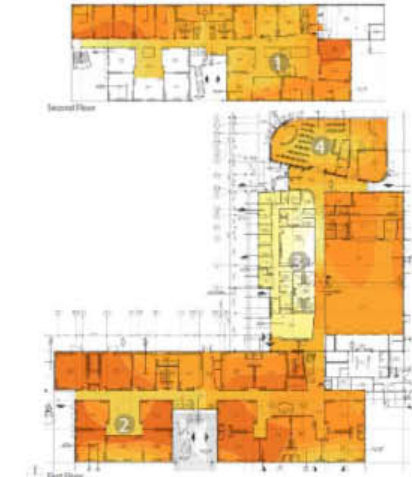
Afternoon Measurements-Summer Occupancy

Second Floor  
1,1420 lux 2,670 lux 3,4000 lux 4,1590 lux

First Floor  
1,1420 lux 2,670 lux 3,4000 lux 4,1590 lux

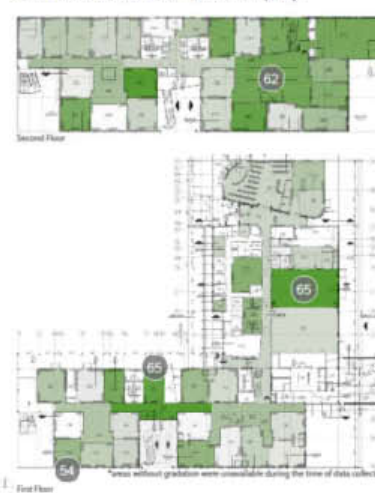
Sound Source Measurements - Summer Occupancy

Second Floor  
Some without gradation were considerable during the time of data collection.

First Floor  
Some without gradation were considerable during the time of data collection.

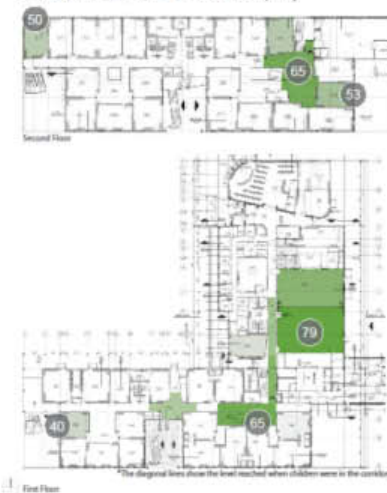
Sound Source Measurements - Normal Occupancy

Second Floor  
The diagonal lines show the level reached when children were in the cafeteria.

First Floor  
The diagonal lines show the level reached when children were in the cafeteria.

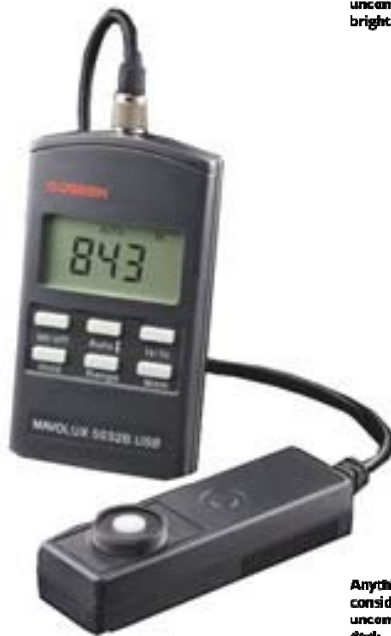
Anything above considered uncomfortably bright

5,000 Lux

Anything below considered uncomfortably dark

250 Lux

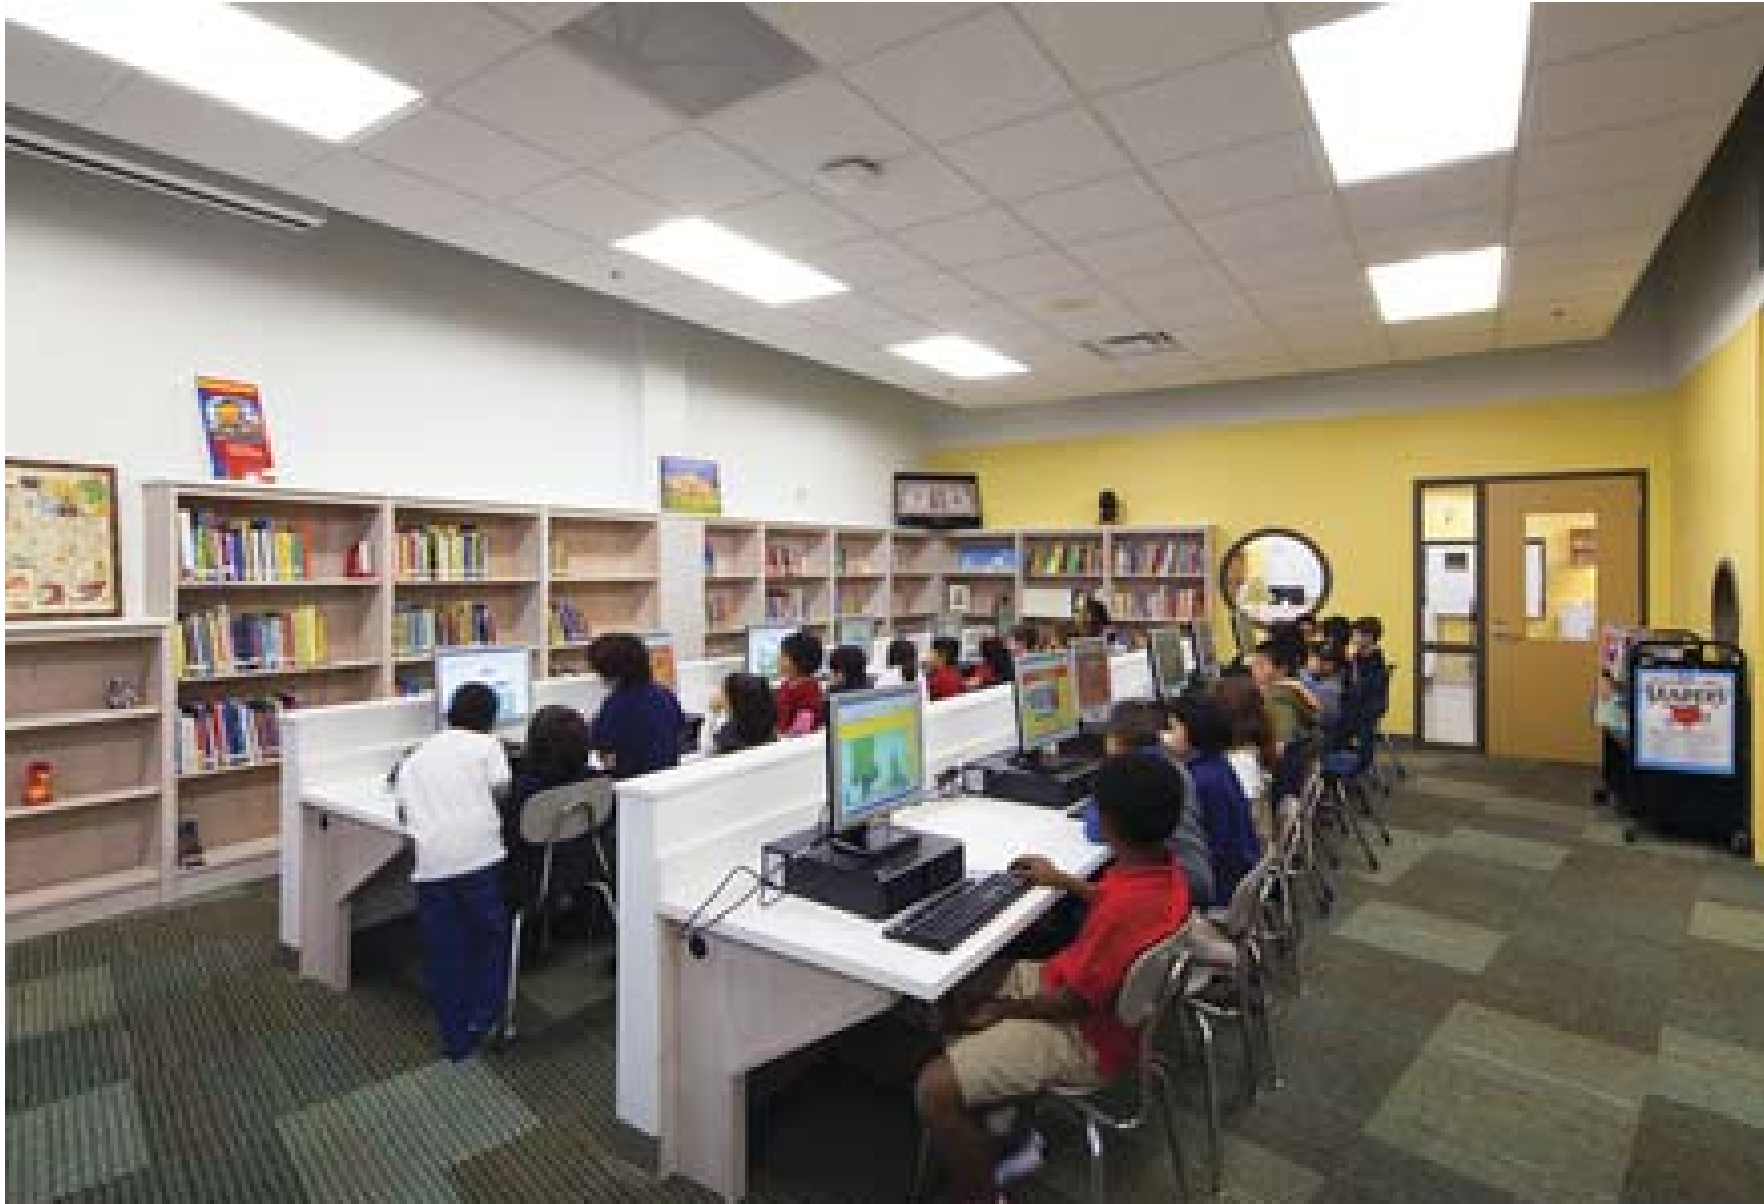
CASE 2:  
SUBURBAN ELEMENTARY

PROBLEM:  
THERMAL COMFORT COMPLAINTS  
FROM CERTAIN ROOMS,  
PARTICULARLY THE LIBRARY

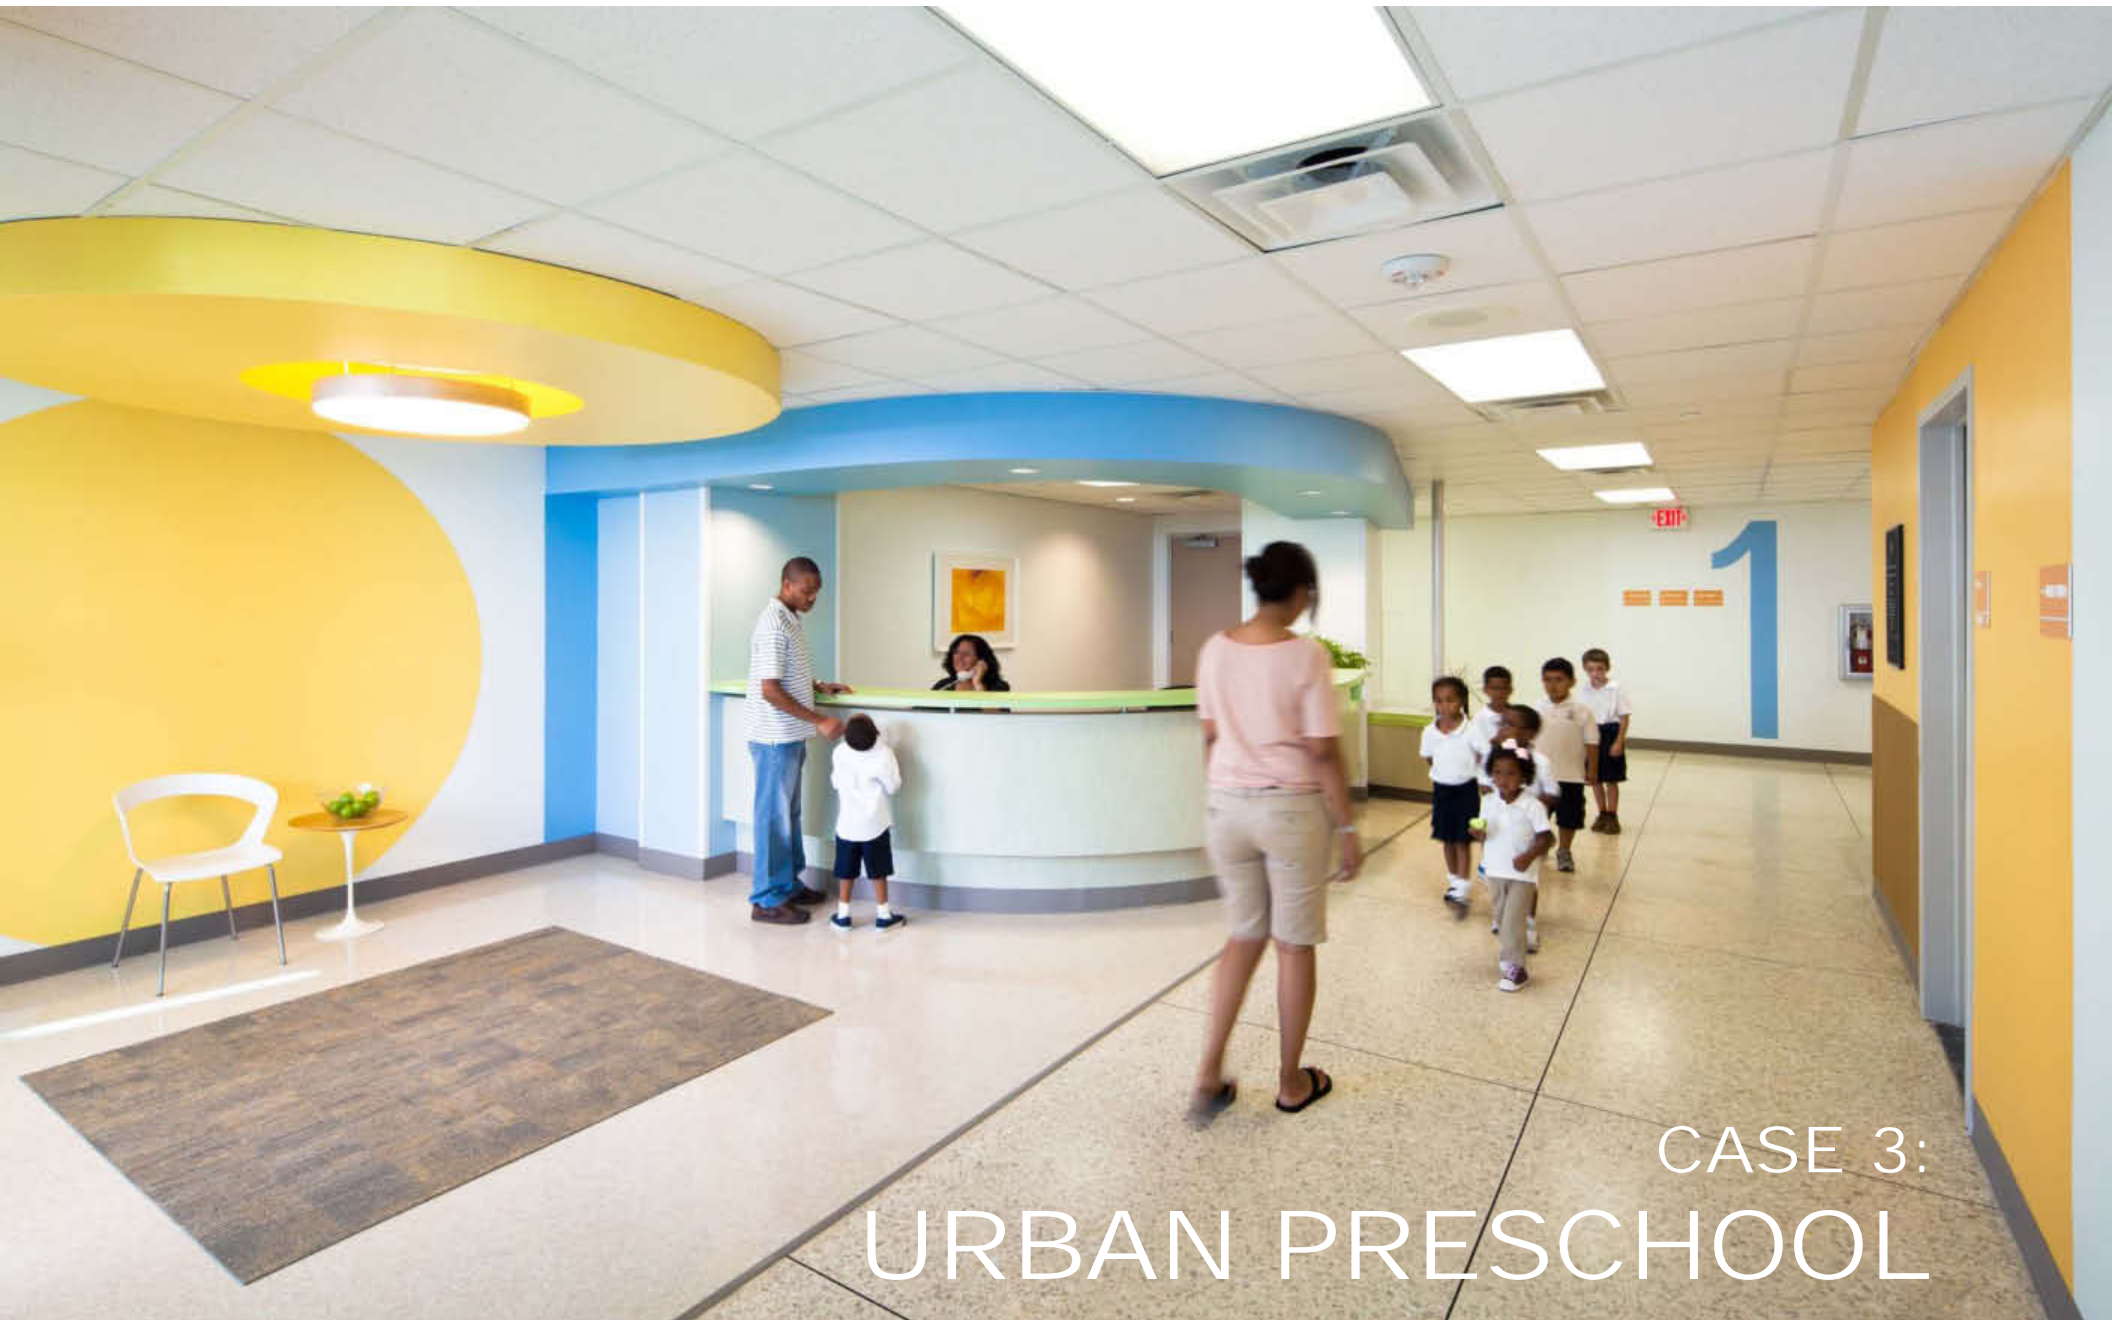
CASE 3:  
URBAN PRESCHOOL

PROBLEM:

TEACHERS COMPLAIN THAT STUDENTS  
STRUGGLE WITH FOCUSING AND  
FOLLOWING INSTRUCTIONS

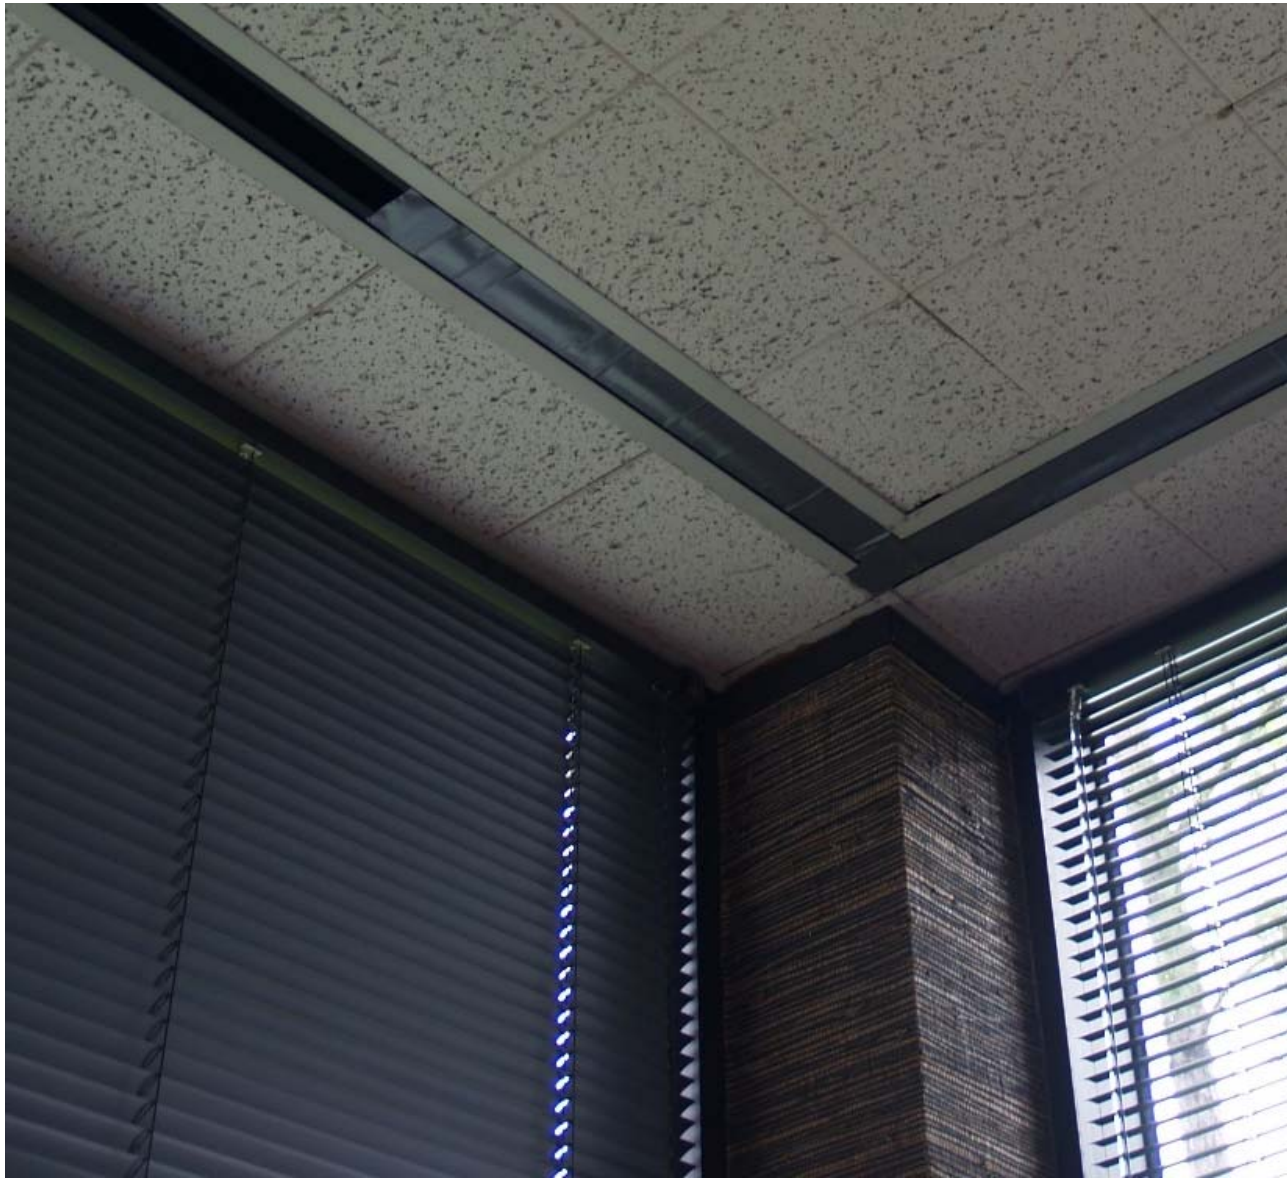
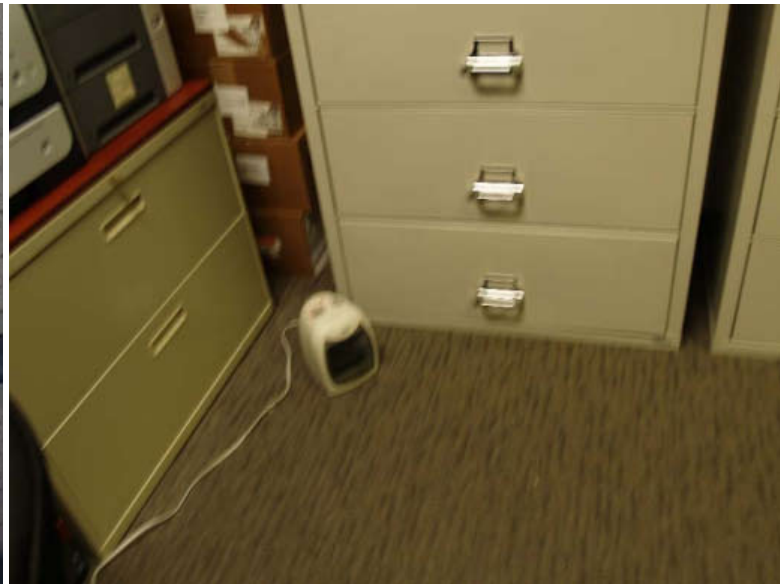
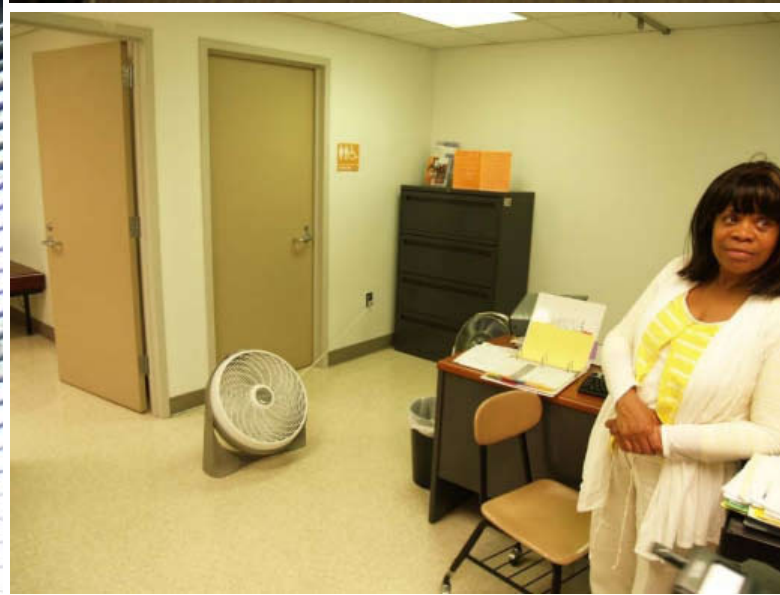
4. LOOK FOR HANDMADE FIXES

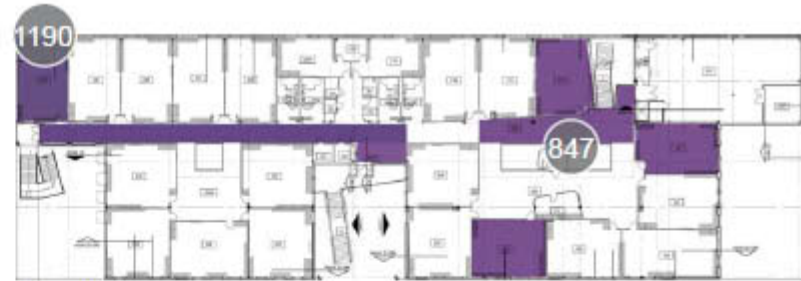
CO2 Measurements - Normal Occupancy

Second Floor

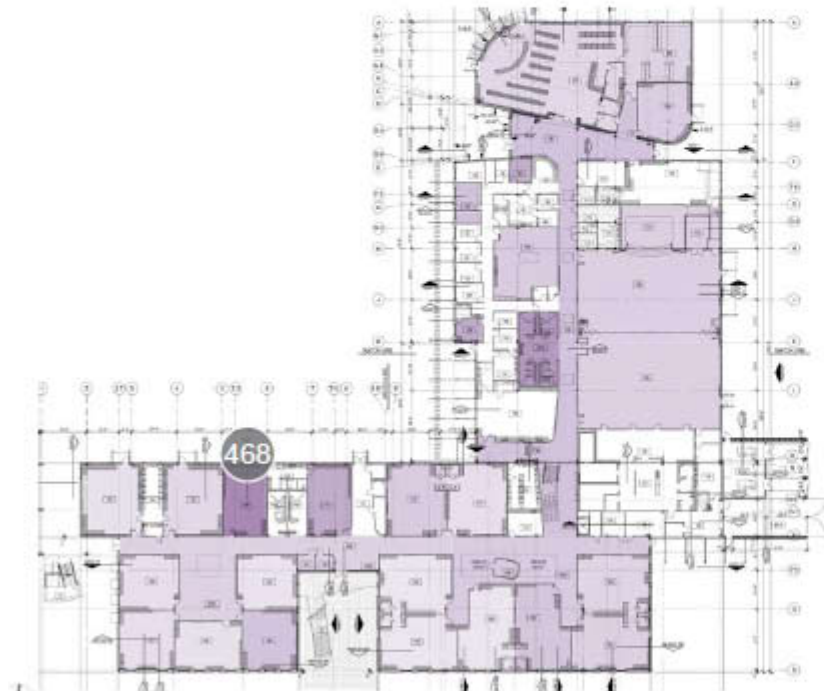
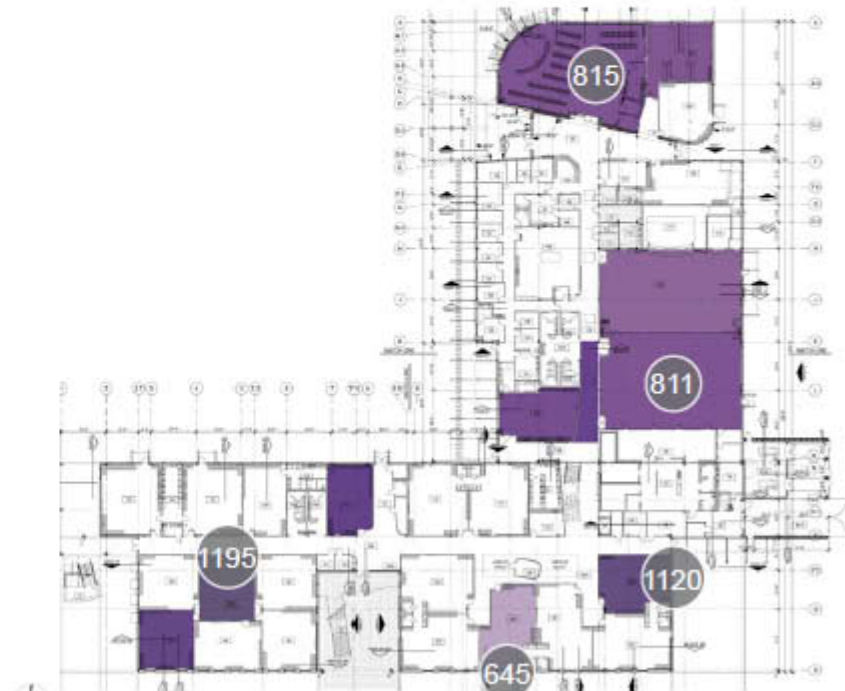
CO2 Measurements - Summer Occupancy

Value Gradient (PPM)

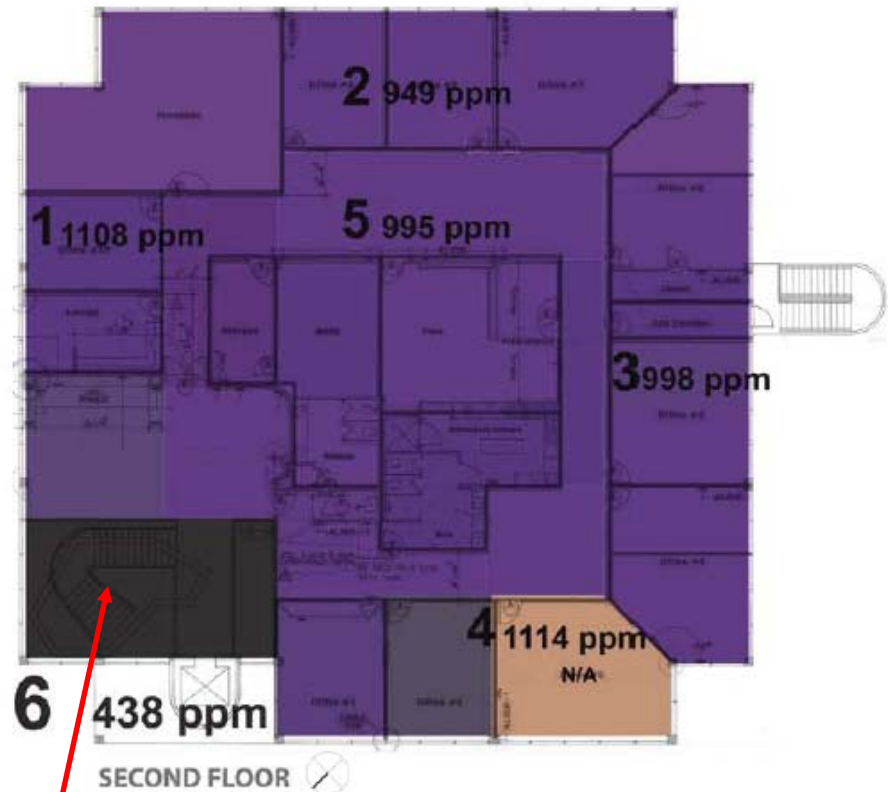
Carbon Dioxide Measurements

Value Gradient (PPM)

1507 PPM !!!

- ▶ 47% of respondees are satisfied with indoor air quality, and 17% are extremely satisfied
- ▶ 32% of respondees said air quality related symptoms improved away from work
- ▶ Occupants have expressed dissatisfaction with kitchen odors and stuffy air, which relates to the low score of -0.25 in Zone 5 of the first floor.
